REPORT ON THE STATE OF PIKE LAKE AND ITS WATERSHED

July 2009

Pike Lake Community Association and Volunteers
With Assistance from the Lake Management Planning Program

Draft Report on the State of Pike Lake and its Watershed 2009 — Executive Summary

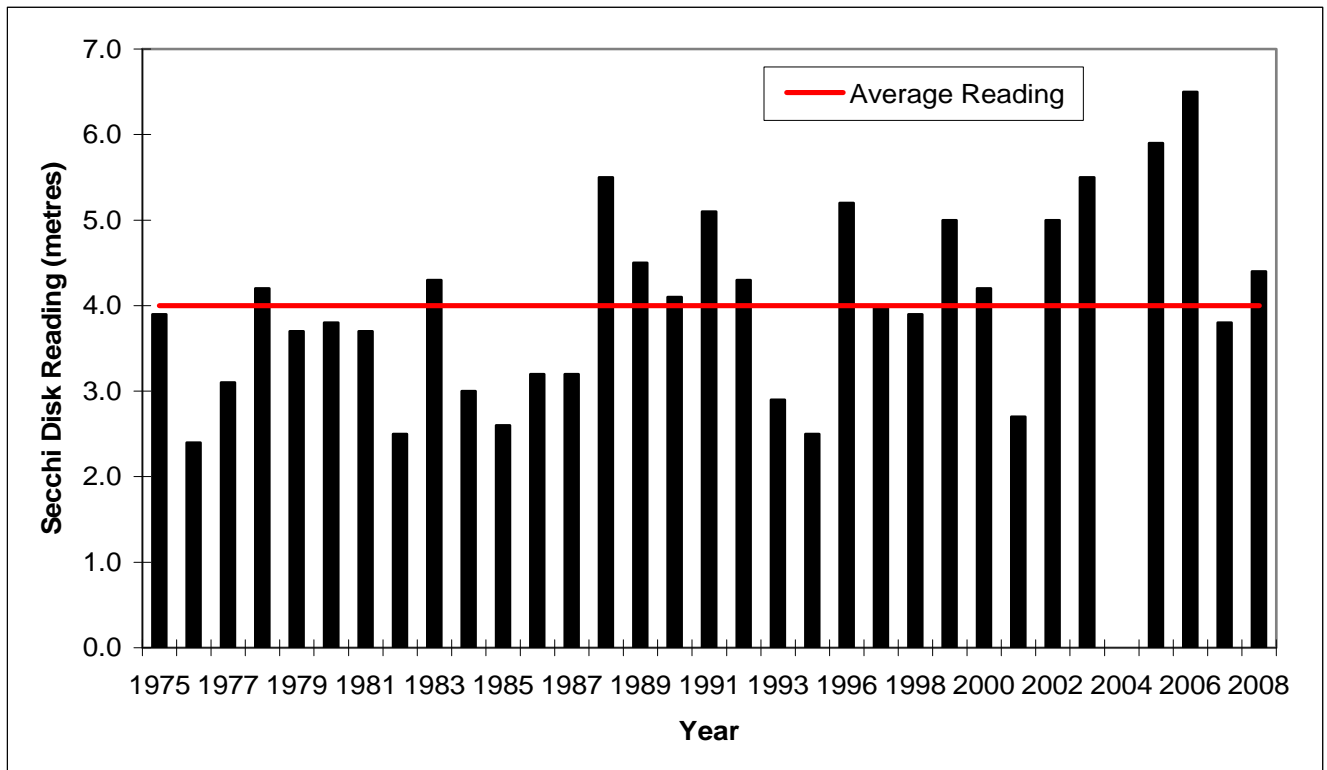
Figure 1: Pike Lake Average Annual Water Clarity Based on Secchi Disk Depth

Since 1975, water clarity has been measured at the deep point of the lake by lowering a black and white disk (Secchi disk) into the water until it is no longer visible.

Water clarity measurements have ranged from 2.4 m (8 ft) to 6.5 m (21 ft). Average water clarity over 31 years of data is 4.0 m (13 ft). This reading supports a mesotrophic classification (Secchi disk readings between 2 – 5 m) (Refer to Figure 1).

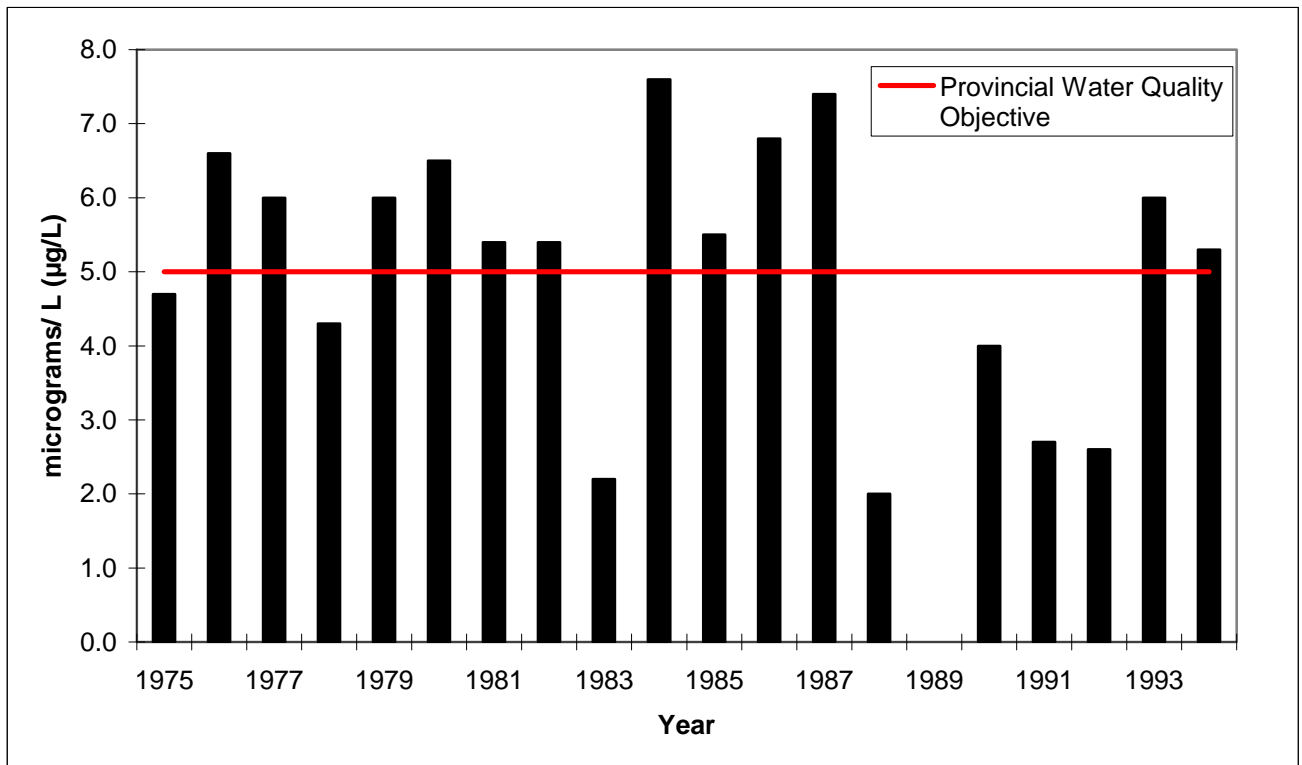
Figure 2: Average Annual Chlorophyll *a* samples taken on Pike Lake (1975- 2001)

Chlorophyll *a* is a pigment that makes plants and algae green. Plants and algae use this pigment to trap the energy from the sun so they can grow. Samples of chlorophyll *a* collected at the deepest point on the lake from 1975 to 1994 were used as an estimate of potential plant growth and of the abundance of algae in the water. As discussed earlier, too much algae can cause problems. As algae die, bacteria eat them. This activity uses up the available oxygen in the water which reduces the ability of aquatic plants, fish and other aquatic organisms to survive.

The **Provincial Water Quality Objective (PWQO)** for chlorophyll *a* was a maximum of 5 micrograms per litre (µg/L). In 1994, total phosphorus became the standard for assessing the biological productivity of a lake. In the 19 years of sampling up to 1994, 65% of the annual averages exceeded the PWQO (refer to Figure 2 for sampling results). For those years, samples

indicated an excessive quantity of algae in the lake, which has negatively affected water clarity and oxygen levels on the lake.

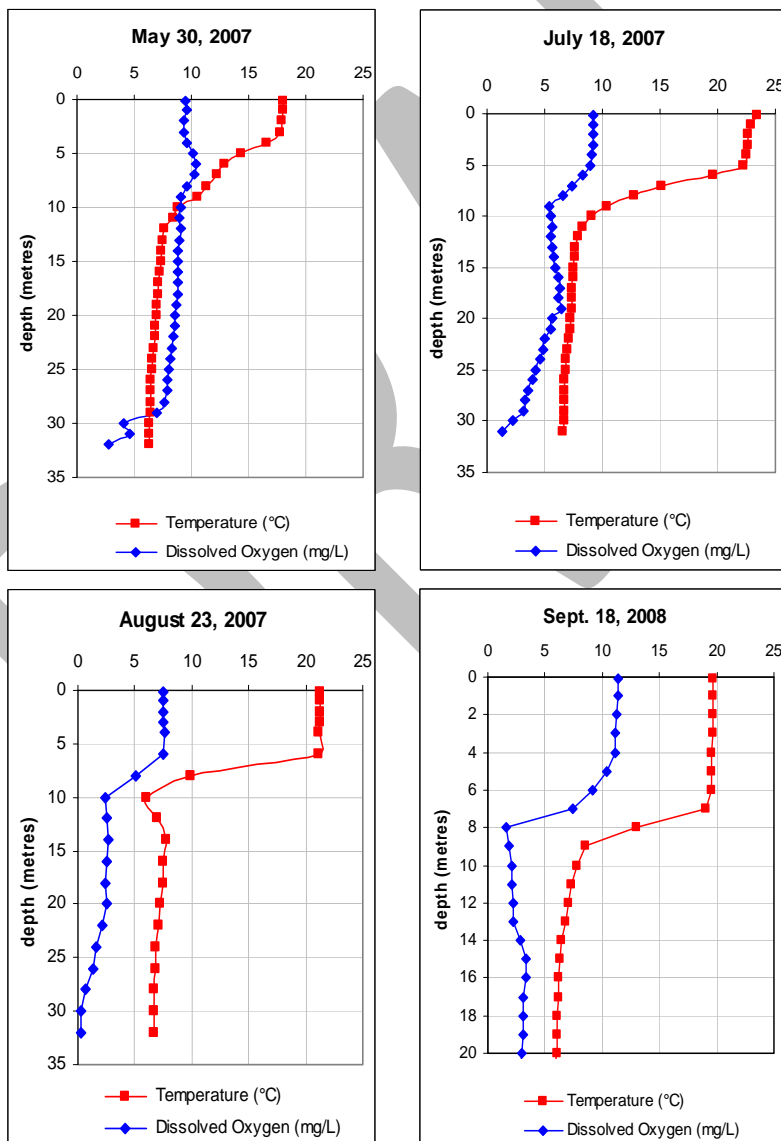
Figure 3: Temperature and Dissolved Oxygen Profiles taken on Pike Lake in 2007 and 2008

The Watershed Watch Program collected dissolved oxygen and temperature profiles three times in 2007 and once in 2008. The relatively short winter with very late ice formation on the lake in 2006/2007 may have been the reason for slightly higher oxygen concentrations at ice-out in May. When the second profile was done in July, there was still close to 10 mg/L of oxygen in the upper 5 m (16 ft) and sufficient oxygen for most fish species to 25 m (82 ft) depth.

In 2008, when the DO and temperature profile was completed in September, conditions were anoxic in the water column at a depth of approximately 14 m (46 ft). Figure 3 outlines the dissolved oxygen and temperature profiles measured in 2007 and 2008 on the lake.

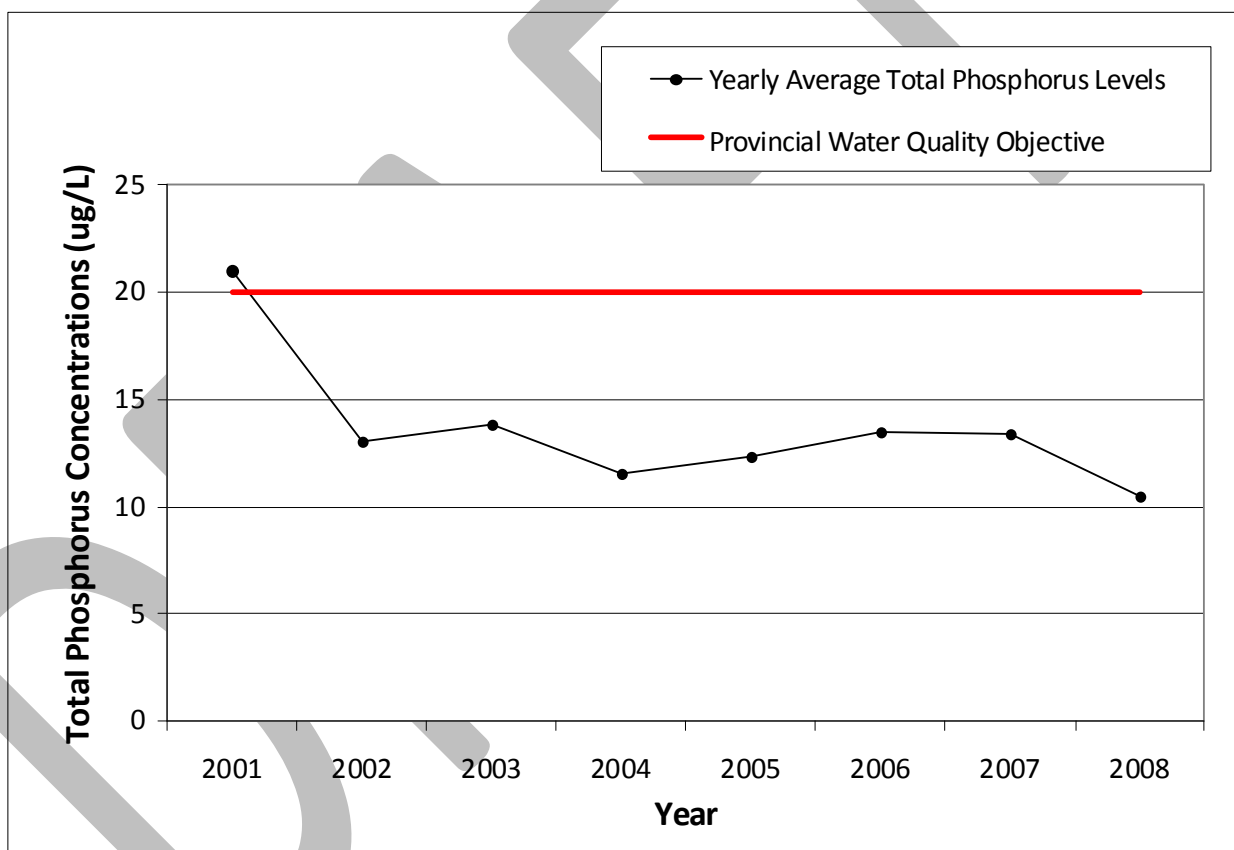
Figure 4: Yearly Average Total Phosphorus on Pike Lake (2001 - 2008)

Figure 4 below shows the Watershed Watch Program total phosphorus results measured at all of the independent sample sites around the lake from 2001 to 2008. The figure shows that, on average, the phosphorus concentration measured on the lake falls within 8 – 15 µg/L. Many of the samples shown above the PWQO of 20 µg/L are taken from Watershed Watch Site D. Found at the eastern bay of the lake, this sampling site is at the mouth of the wetland area that drains the area next to the Stanleyville Waste Disposal Site. Since 2001, results from the sampling site (Site D) at the stream near the disposal site show there are higher concentrations of TP and TKN flowing toward the lake (Refer to Table 2). Although it is likely the results at site D on the lake are a product of inflow from the stream, specific investigative sampling on the stream would be needed to definitively demonstrate what the source is of the higher nutrient concentrations measured at the lake site.

Elevated average loadings of TP were recorded in 1993 and 1996. Sampling from the deepest point of the lake has exceeded the PWQO every year since 2001 to 2006 but not in 2007 and 2008. Recent years (2007 and 2008) did not have phosphorus exceedances (Refer to Figure 4). The average phosphorus concentration measured from 2001 to present is 14 $\mu\text{g/L}$., which puts Pike Lake in the mesotrophic category as also indicated by the previous parameters discussed.

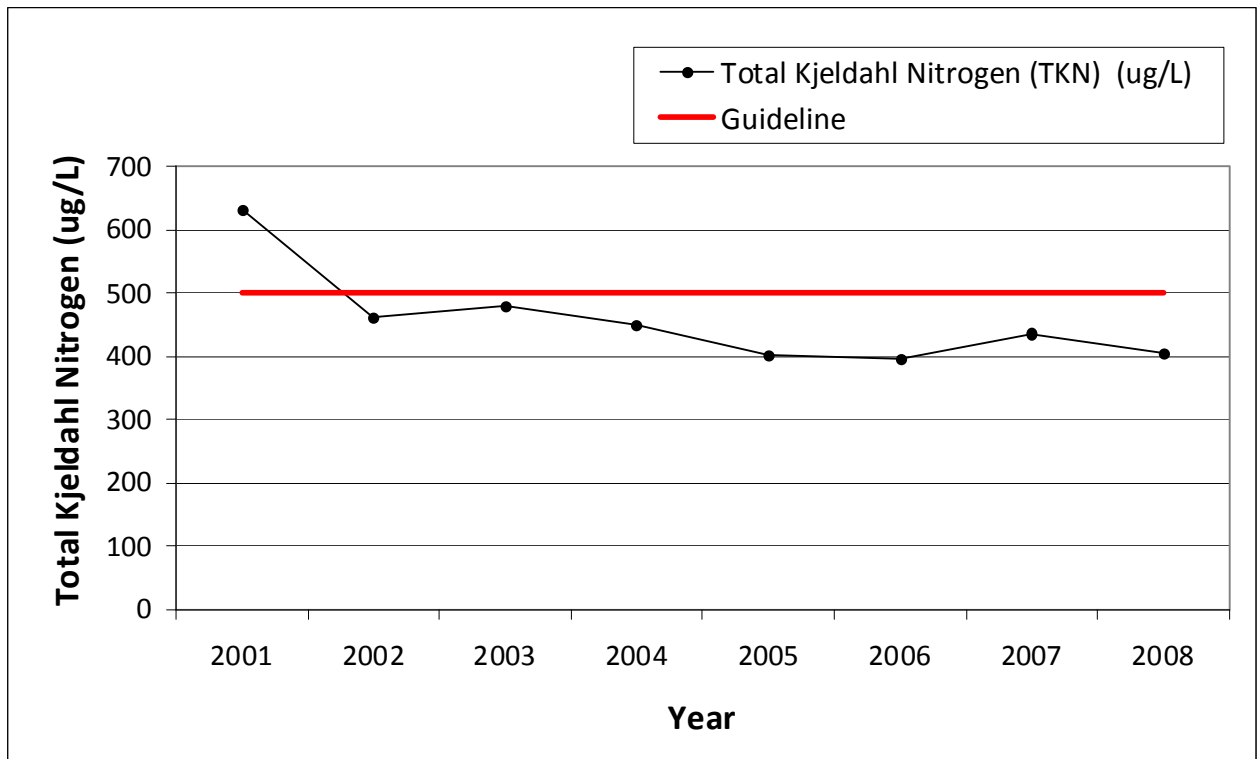
Figure 5: Yearly Average Total Kjeldahl Nitrogen on Pike Lake (2001 - 2008)

Nitrogen is another significant nutrient in all lakes. Measured as Total Kjeldahl Nitrogen (TKN) micrograms per litre (µg/L), it includes all organic nitrogen and ammonia found in a water body. High concentrations may be indicative of excessive nitrogen entering the lake. Naturally occurring sources of nitrogen include the atmosphere, animal and human waste, decaying

organic matter, and live organic material including algae. High nitrogen concentration can cause organic nitrogen enrichment of lake water.

Since 2001, Site D continues to have higher concentrations of both total phosphorus and total Kjeldahl nitrogen (Refer to Table 2). It is likely the results at site D are a product of inflow from the stream. TP and TKN sampling on the stream is needed to definitively demonstrate what the contributing source of the higher nutrient concentrations measured at the lake site.

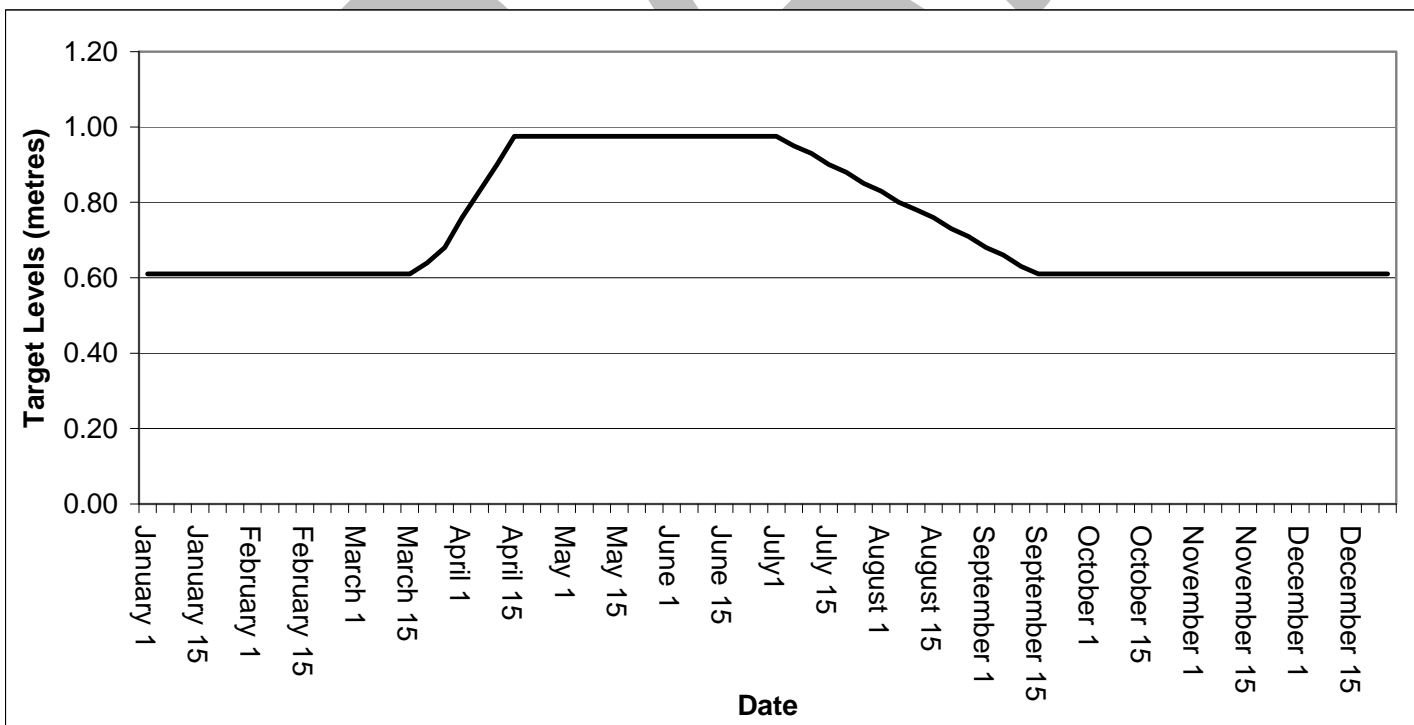
Figure 6: Kemptville MNR Water Level Targets for Pike Lake

- Around September 15th, the logs are adjusted to winter operating conditions (with 2 logs remaining in each sluiceway) lowering the lake's water level to 0.61 m (2 ft). This lower water level helps water level management during the upcoming spring melt (McLenaghan, 2007, Kemptville MNR). Refer to [Appendix 10](#) for the rule curve water target levels.

Although target water levels have been established for this system, lake levels can be off-target. Higher or lower water levels can be the result of significant weather and precipitation events. Spring run-off (spring freshet) increases flows into the lake system; hot, dry, and windy weather can result in lower lake levels due to increased evaporation from the lake surface and reduced water input. When the weather is cool, overcast, and rainy, lake levels are typically higher. Initial log adjustments during these events may not correctly match the results of these weather conditions or events since the number of logs removed or replaced is an estimate to the effects of the amount of precipitation; further adjustments may be necessary (McLenaghan, 2007).
